RAILROAD ACCIDENT REPORT

HEAD-ON COLLISION OF
CSX TRANSPORTATION FREIGHT TRAINS
EXTRA 4443 NORTH AND EXTRA 4309 SOUTH
EAST CONCORD, NEW YORK
FEBRUARY 6, 1987

NTSB/RAR-88/03

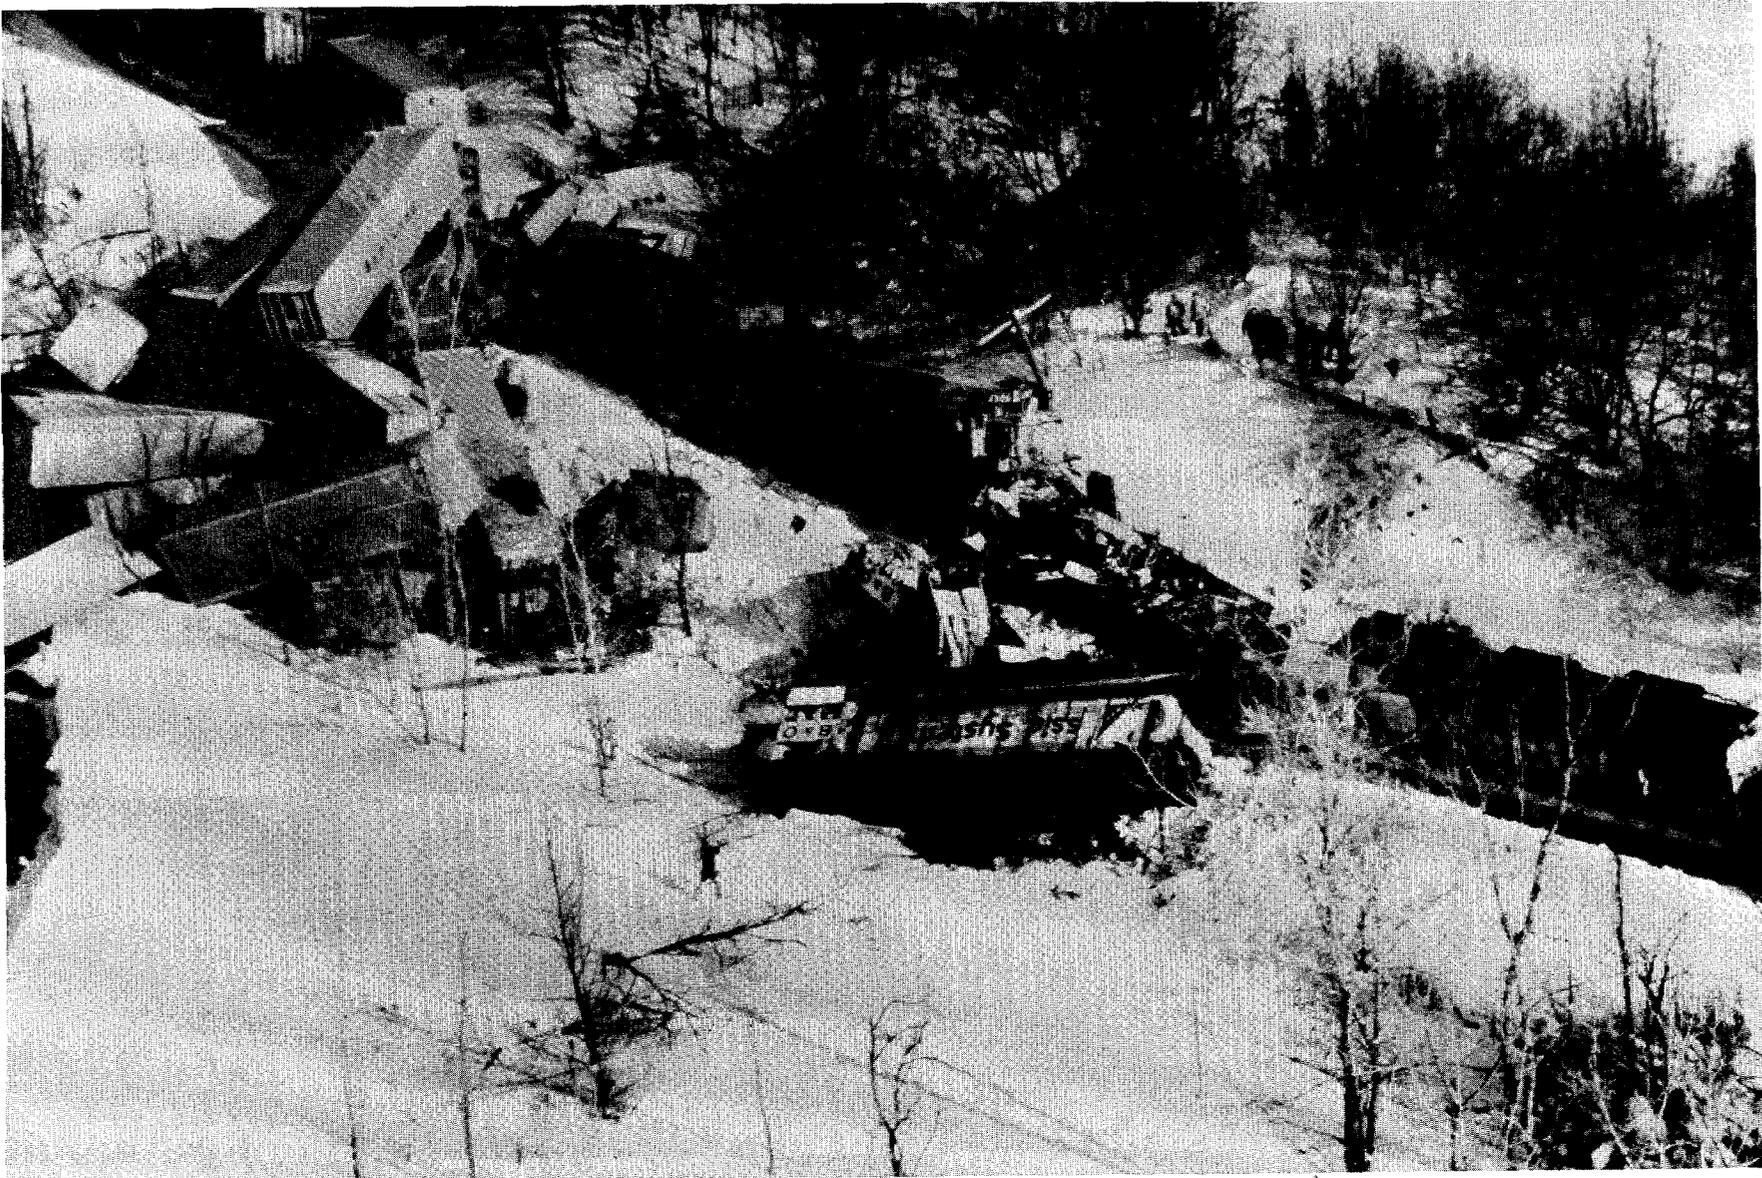
The two lead locomotive units of Extra 4443 North were destroyed. The car body of the lead locomotive unit was sheared off at the platform level. It overturned toward the west, and the operating compartment was crushed. The second unit overturned and came to rest parallel to the lead unit. The third and fourth units were both derailed, but remained upright. Of the eight cars derailed, six were substantially damaged, and two sustained minor damage. (See figure 2.)

The lead locomotive unit of Extra 4309 South was destroyed, and the second unit was substantially damaged. Three freight cars derailed. (See figure 2.)

Figure 2.--Eastward view of accident site showing Extra 4309 South (left) and Extra 4443 North (right).
